LAKE SURVEY MAP

TUMA LAKE
MANITOWOC COUNTY
SEC. 17 T. 21 N. R. 23 E

EQUIPMENT RECORDING SONAR MAPPED AUGUST 1973

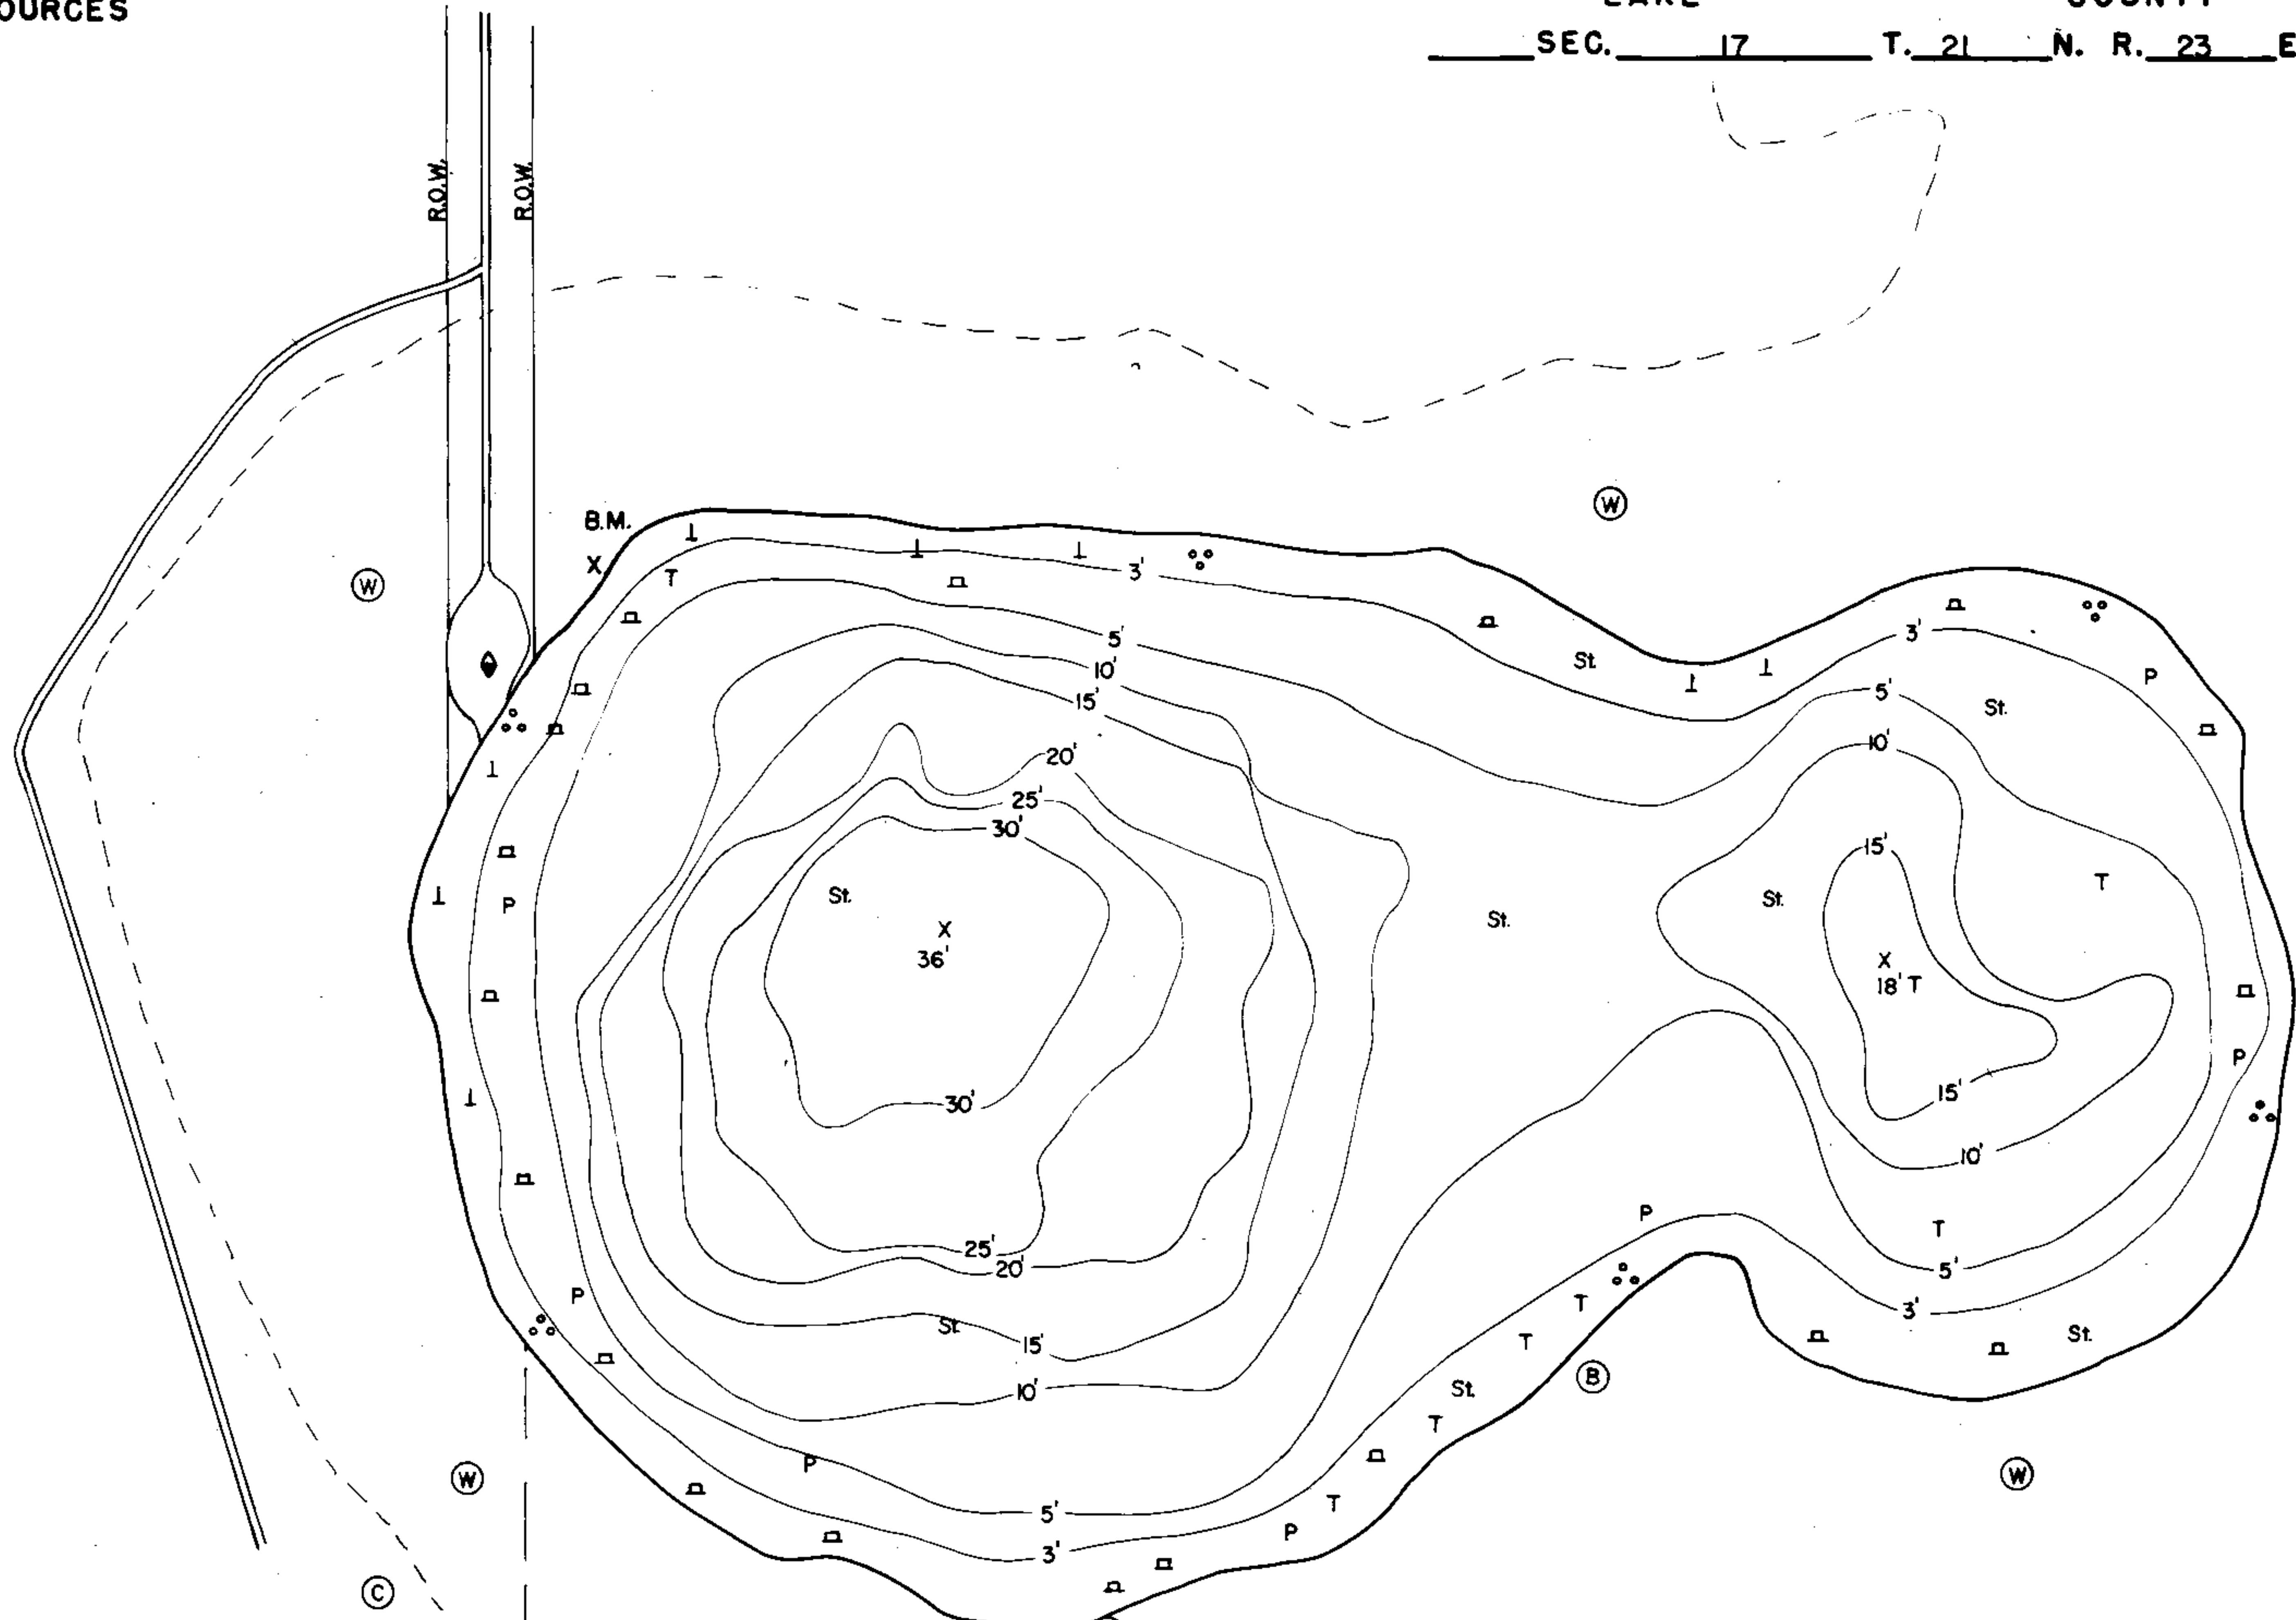
B.M. 'X' is a 1-3/4" pipe along shoreline on E. side of public landing on NW. end of lake.
Assumed Elev. 100.00
Water Elev. 97.10

WATER AREA 13.9 ACRES
UNDER 3 FT. 14 %
OVER 20 FT. 14 %
MAX. DEPTH 36 FEET.
TOTAL ALK. 103 P.P.M.
VOLUME 148.0 ACRE FT.
SHORELINE 60 MILES

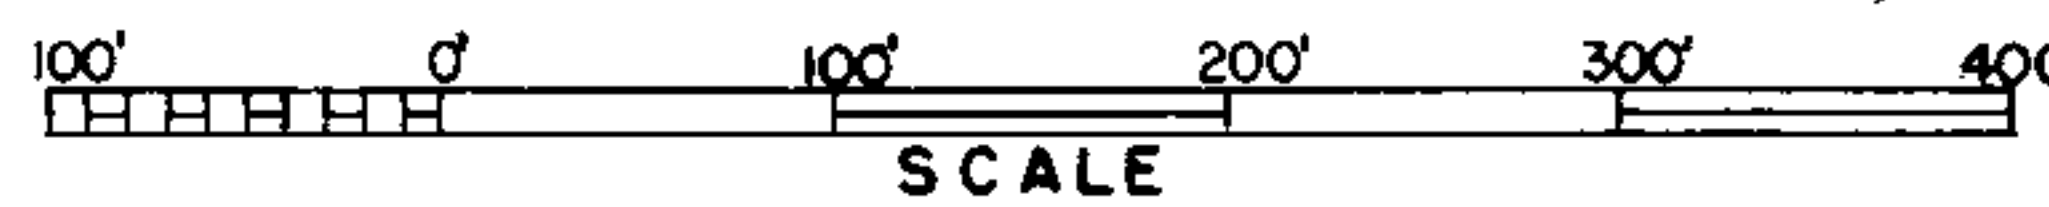
TOPOGRAPHIC SYMBOLS		LAKE BOTTOM SYMBOLS	
(B) Brush	Steep slope	P. Peat	B Boulders
(PW) Partially wooded	----- Indefinite shoreline	Mk. Muck	⊙ Stumps & Snags
(W) Wooded	----- Marsh	C. Clay	⊙ Rock danger to navigation
(C) Cleared	----- Spring	M. Marl	T Emergent vegetation
(P) Pastured	----- Intermittent stream	Sd. Sand	⊥ Submergent vegetation
(A) Agricultural	----- Permanent inlet	St. Silt	⊥ Floating vegetation
B.M. Bench Mark	----- Permanent outlet	Gr. Gravel	⊥ Brush shelters
■ Dwelling	----- Dam	R. Rubble	
■ Resort	----- D.N.R. State owned land	Bc. Bedrock	
■ Camp

Access Access with Parking Boat Livery
